Notice of Discharge Compliance Report (6-16-11)

Inspection type: NOD Compliance

Operation Name: Hartleben Farms

Operation Address: N6560 Hartleben Ln, Wittenberg, WI

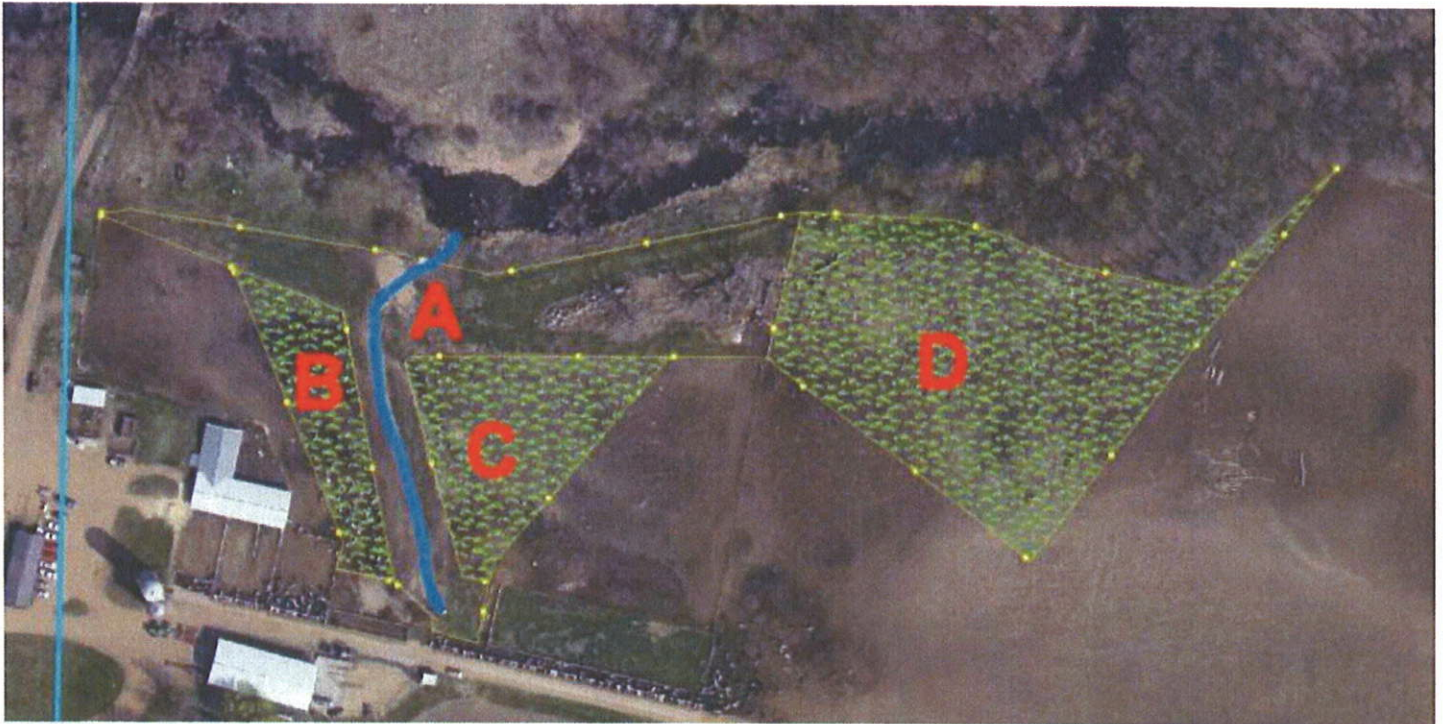
While inspecting the far northeast perimeter of the lot a new runoff problem area was seen. A small portion of the dirt lot drains directly north into the wooded area between the lot and river. There was a substantial amount of accumulated manure solids in the woods.

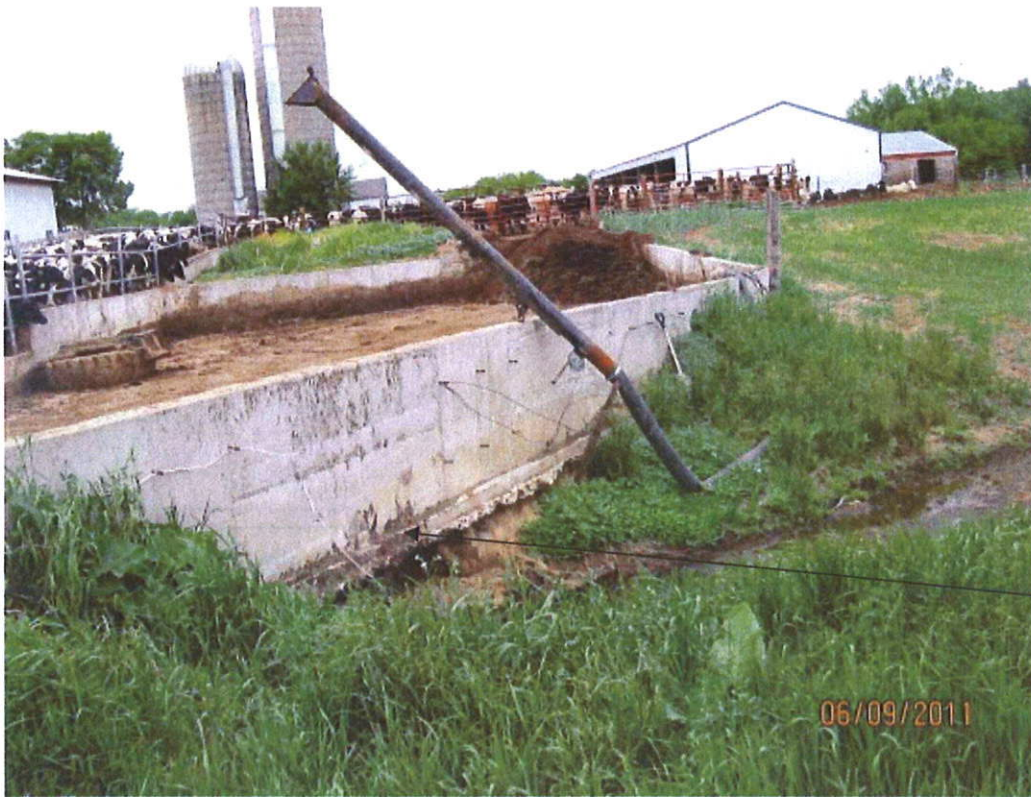
Looking west at manure stacking area. The weephole that had been in the side wall is still plugged. A pump station has been installed to load the water and feedlot runoff that accumulates inside the temporary stacking area.

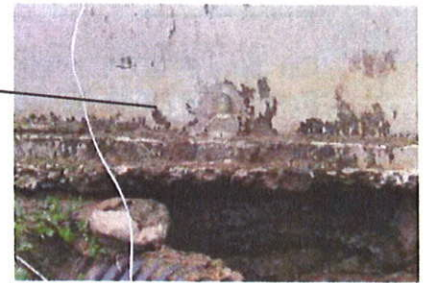
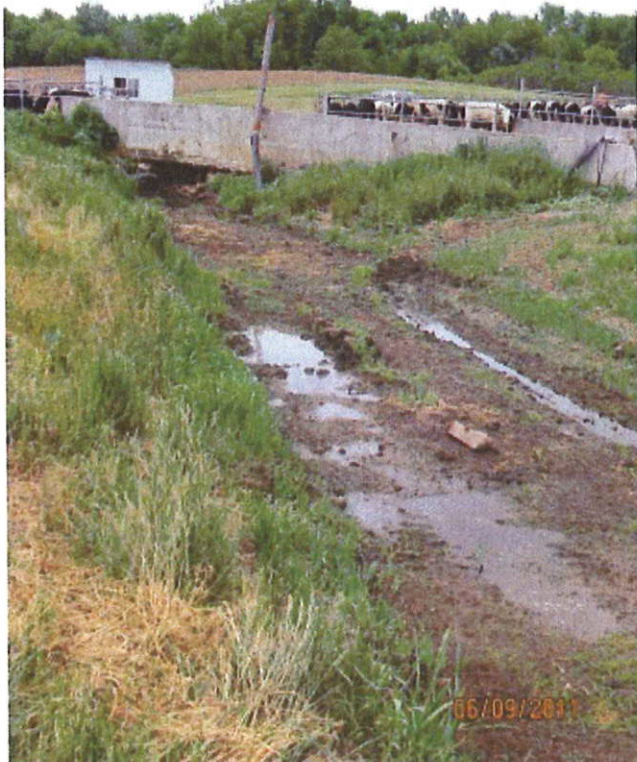
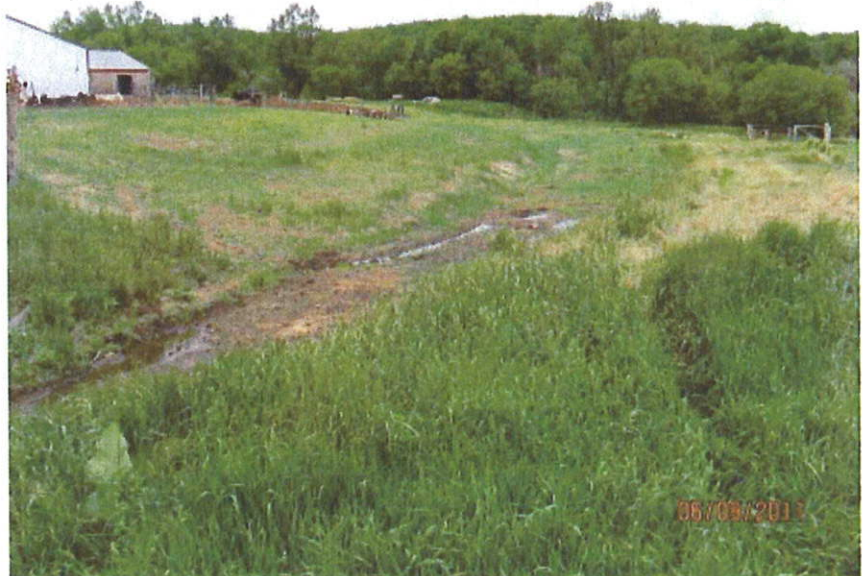
Views of main drainage ditch. High flows from culvert have hindered vegetation growth. Stone may need to be added to this area to help stabilize and prevent erosion. Rest of ditch is graded and vegetated.

On June 9, 2011 Jones inspected the feedlot area along with Shawano County staff, Scott Frank and Blake Schuebel. The areas A, B, C & D from county overview map are vegetated and cows are not allowed access which has reduced runoff risk significantly. The drainage ditch will need to be monitored regularly to prevent channelization and erosion gullies from forming. Due to high flow levels, rock may need to be added to stabilize the area of ditch near culvert outlet.

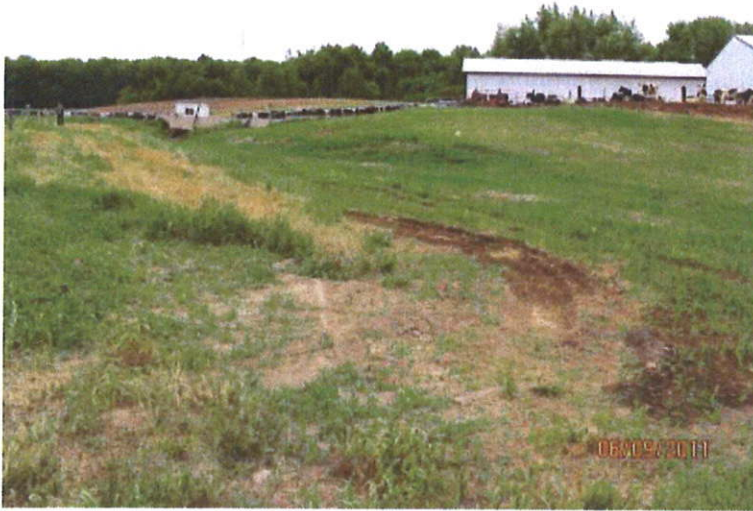
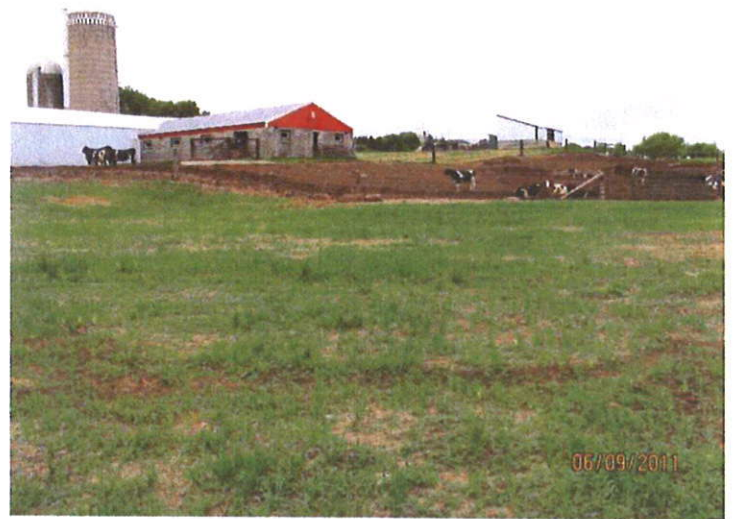
Looking southwest at areas labeled as "A" and "B" on overview map.

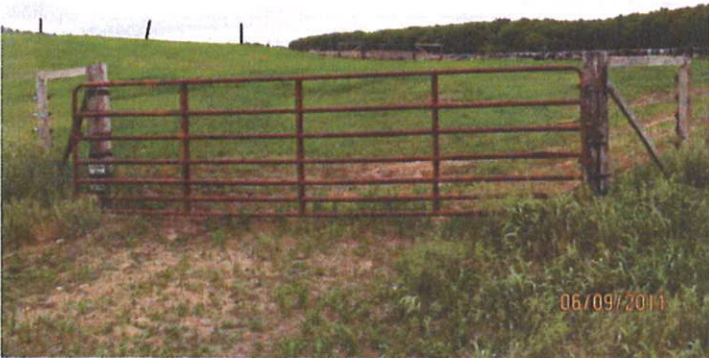
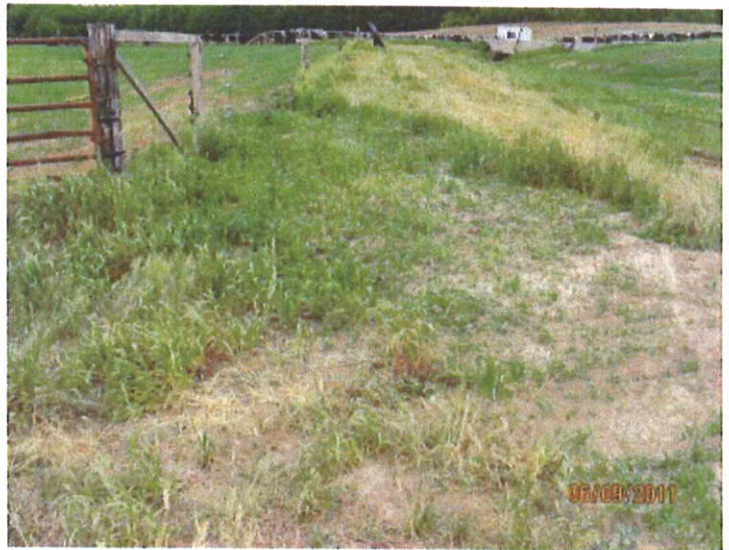
Looking at buffer area "C." This area must remain vegetated at all times.

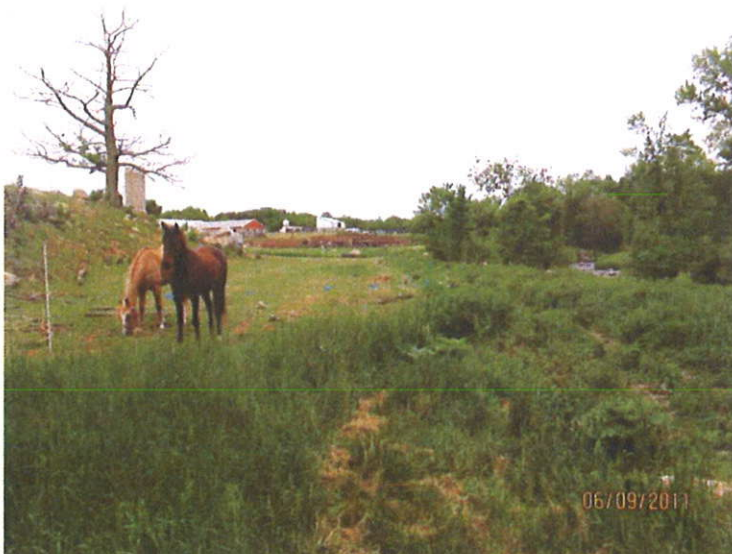
Looking west at area along river. Cattle will not be allowed access to this lot—a few horses may rotationally graze on it as long as it remains vegetated.
